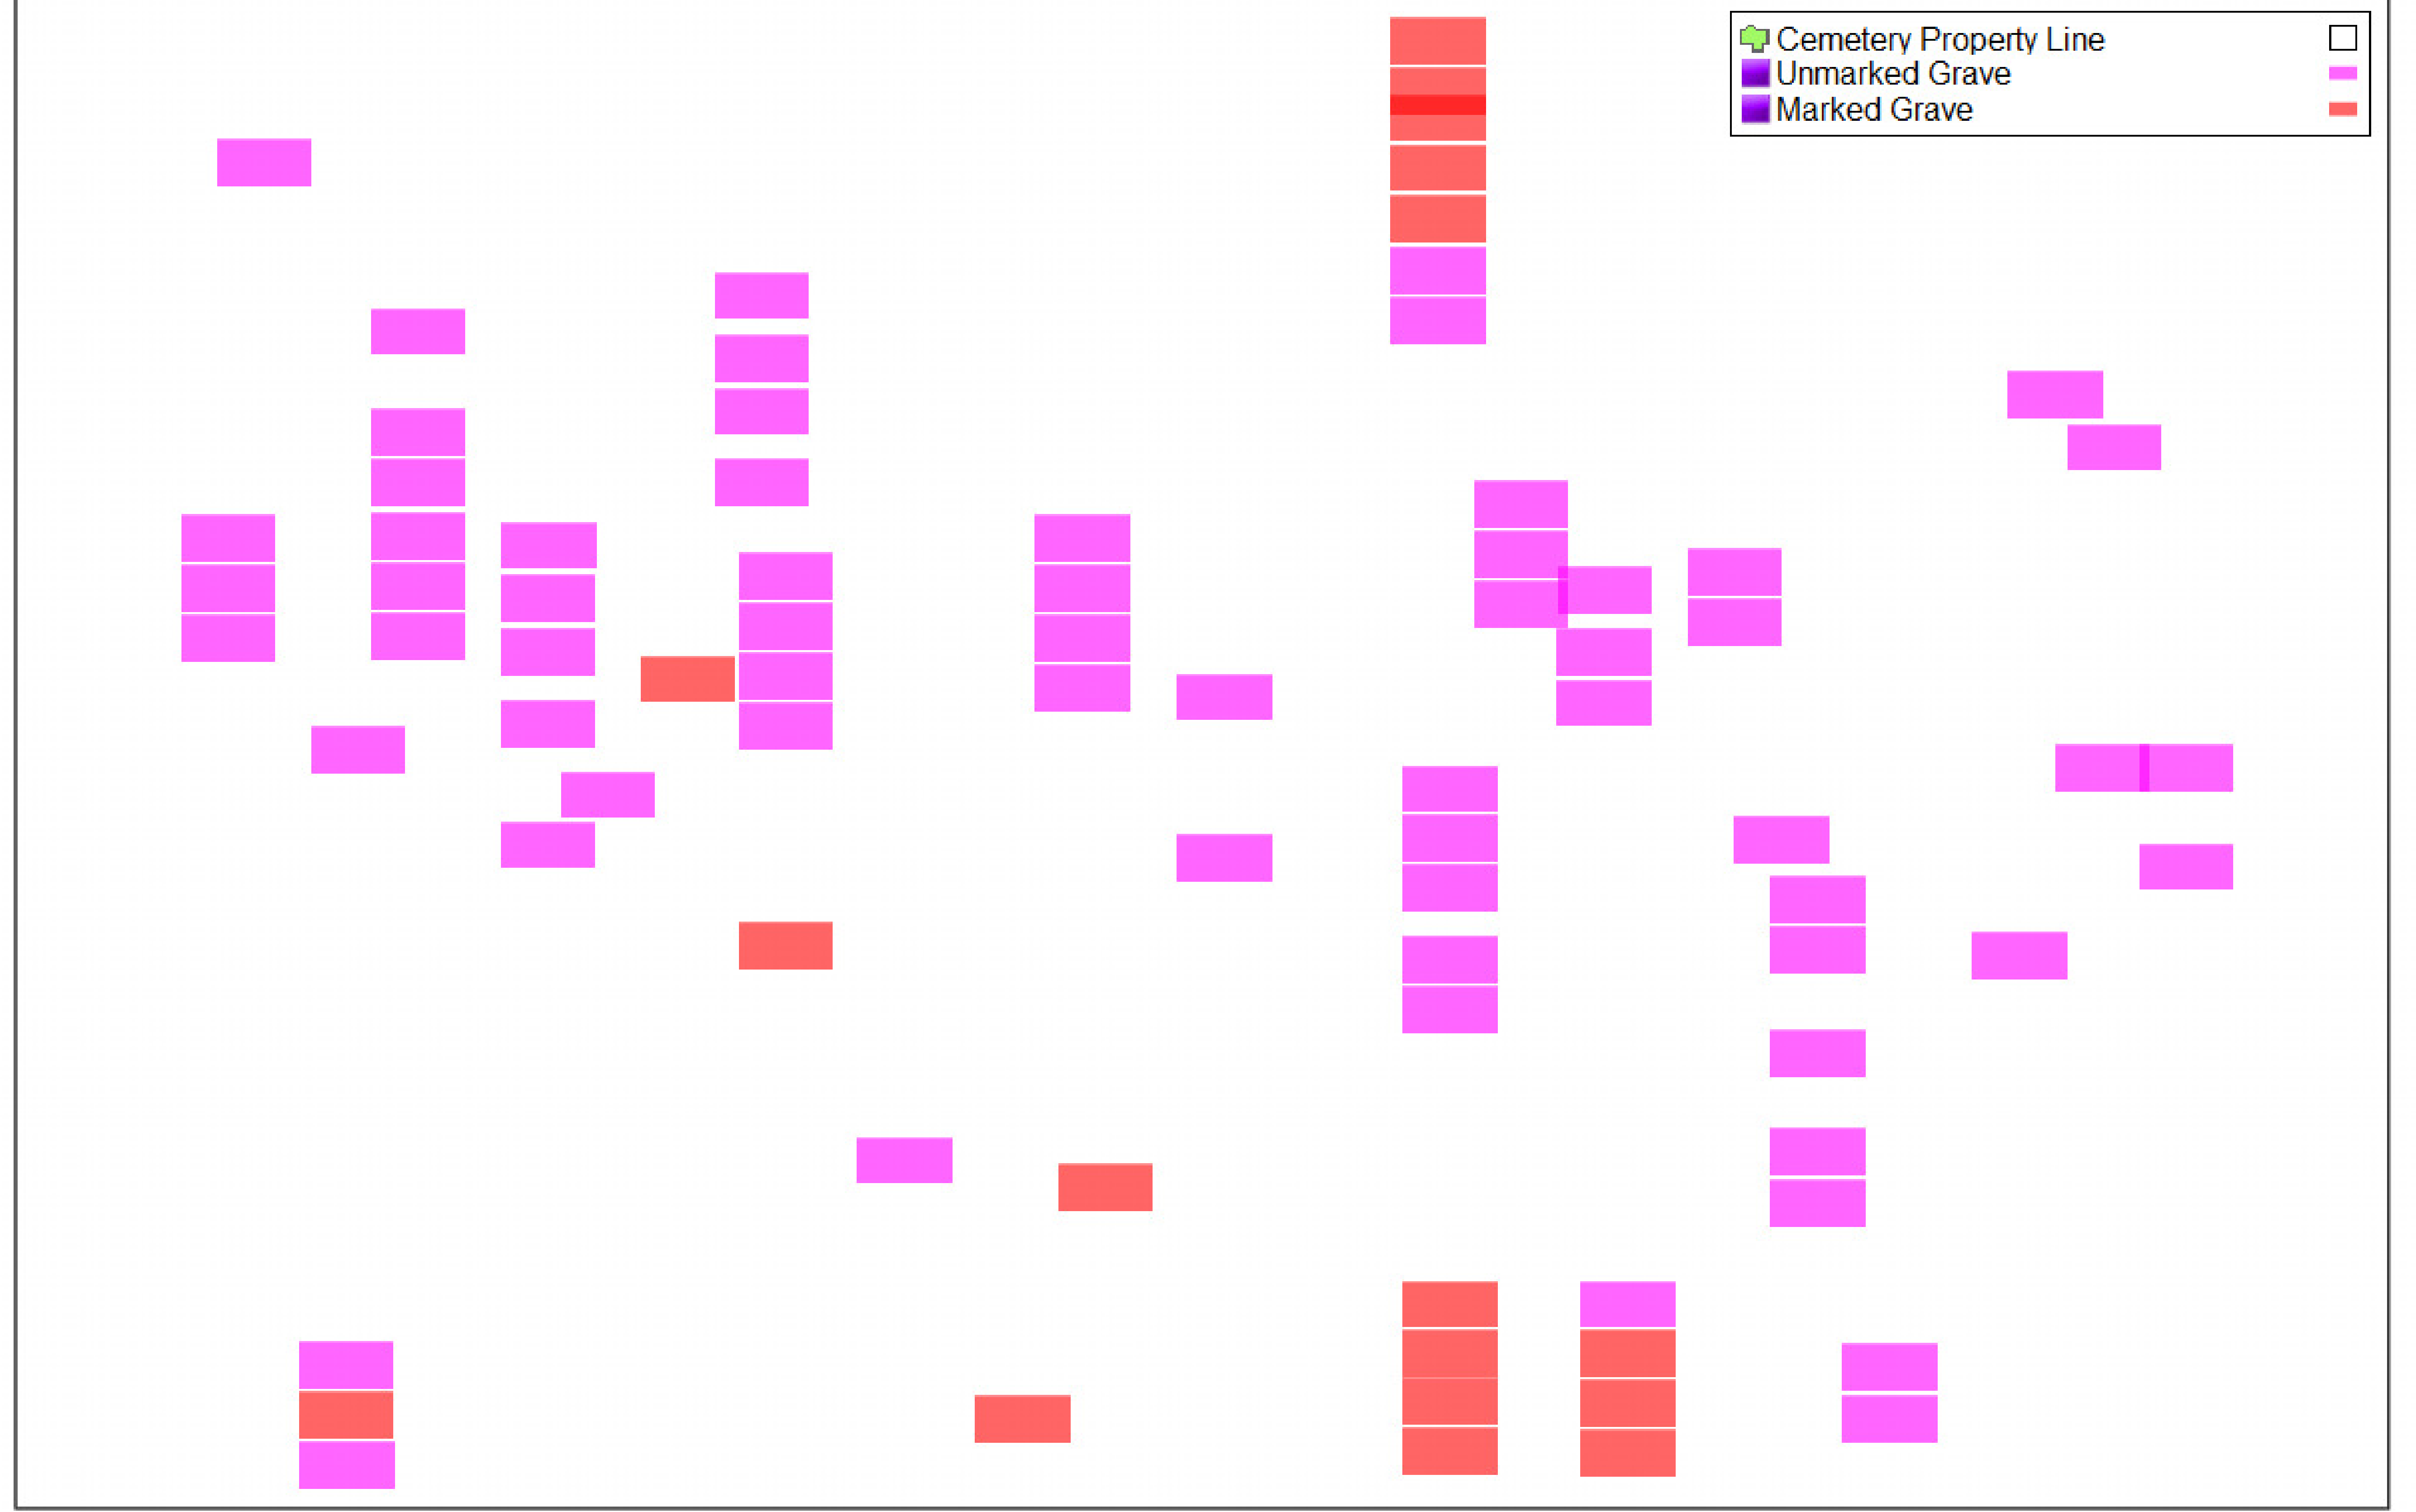
200'-0"

The data collected determined multiple anomalies consistent to that of a full body burial location. These areas were indicated on site with white flags.

There was a total of 64 unmarked burials and 17 marked burials.
